Mangilao Solar Project

Subject: Compliance Assessment – Order Item 1; July 29, 2021 Notice of Violation / Compliance Order / Penalty Order

SUBJECT: Site Inspections at Samsung Mangilao Solar Project Site, August 4, 2021,
for the purpose of compliance determination; Order Item 1

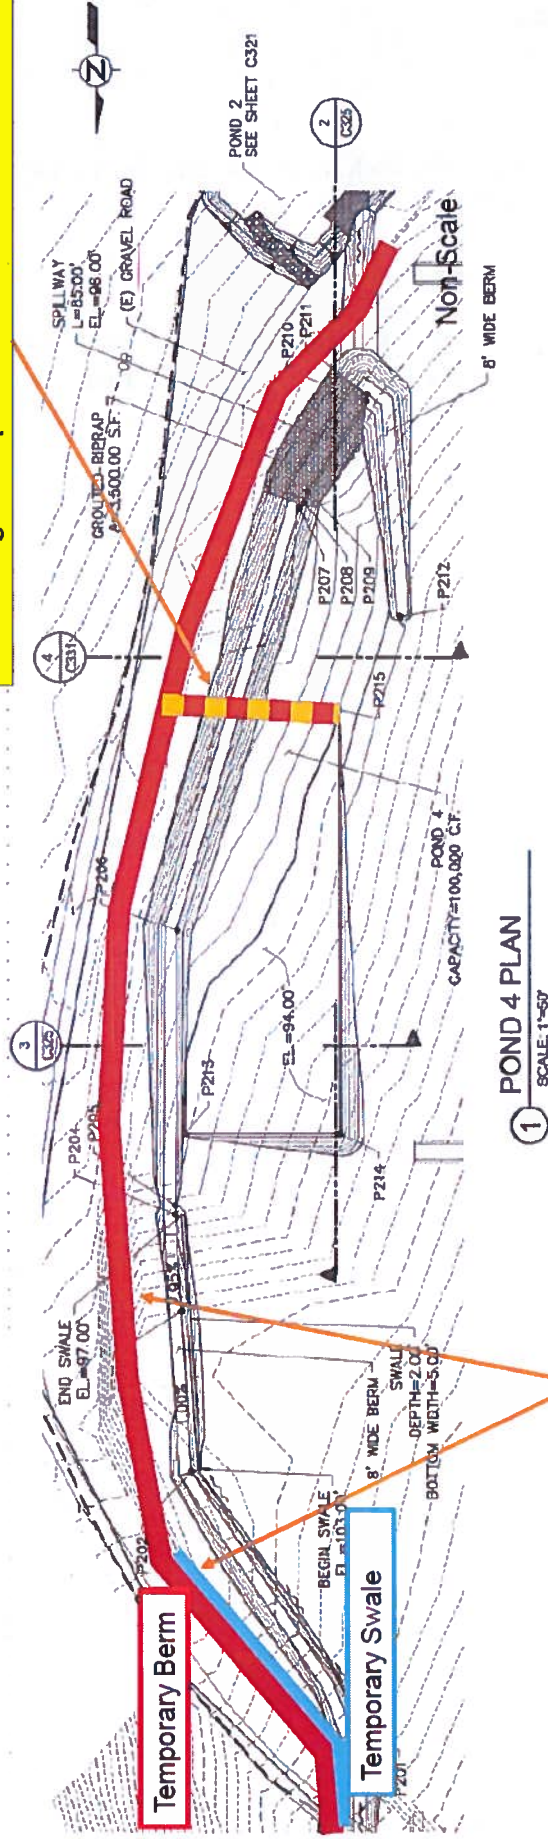
Mangilao Solar Project: Interim Measures on Pond 4

- This temporary berm position will be shifted according to the permanent berm installation.

- Construction temporary berm and swale
- This temporary berm and swale will be maintained until the end of the permanent berm and swale installation.

* Note:
- The material used to construct,
- On-site crushed and screened rock and sandy material,
- Pond 4 is compacted with roller a few times
- The elevation of the temporary berm is similar to the permanent berm.
- There has been ongoing excavation to clean sediment from the basin areas.

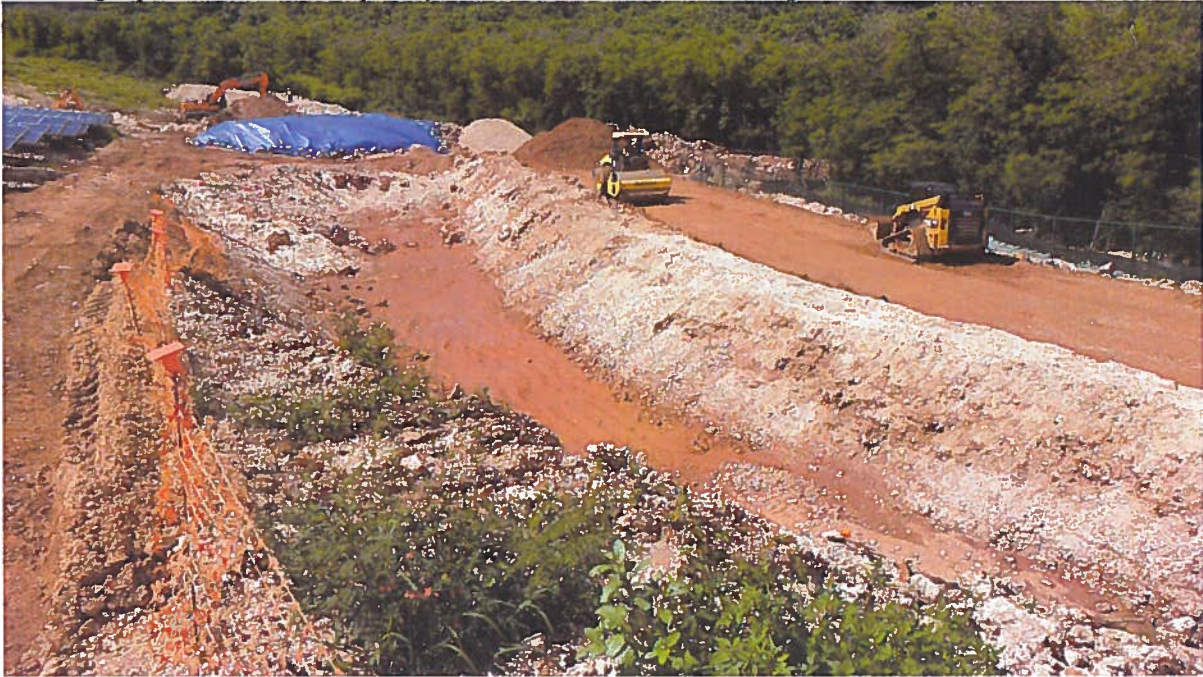
We were then shown the extension of the Pond 5 interim berm system around the area of Pond 5B. Active excavation and grading was underway in this area, and because of that we were unable to see any evidence of how high the water had come in this area on the previous days. The plastic tarp cover on the portion of the temporary berm which had reportedly washed out appeared to be freshly applied, with no visible indication of sediment or a high water mark. Excavation and grading of the areas around Pond 5B was underway, according to Samsung, for the purposes of completing the grading of the swale and surrounding areas. Behind the Pond 5B area was a high berm, which had been placed as the primary interim measure to prevent discharge of runoff from this area toward Marbo Cave.

View of interim measures at Pond 5B location. A temporary berm currently holds water back from the site of active construction of the permanent embankment that will define the full volume of Pond 5B when complete (equipment in picture was working on the permanent embankment emplacement). Sediment from recent rains can be seen in the bottom of the pond, along with indications of a water line about a foot or less above the bottom of the pond. Blue plastic tarp is covering a portion of the temporary berm around Pond 5A. (Aug. 4, 2021)

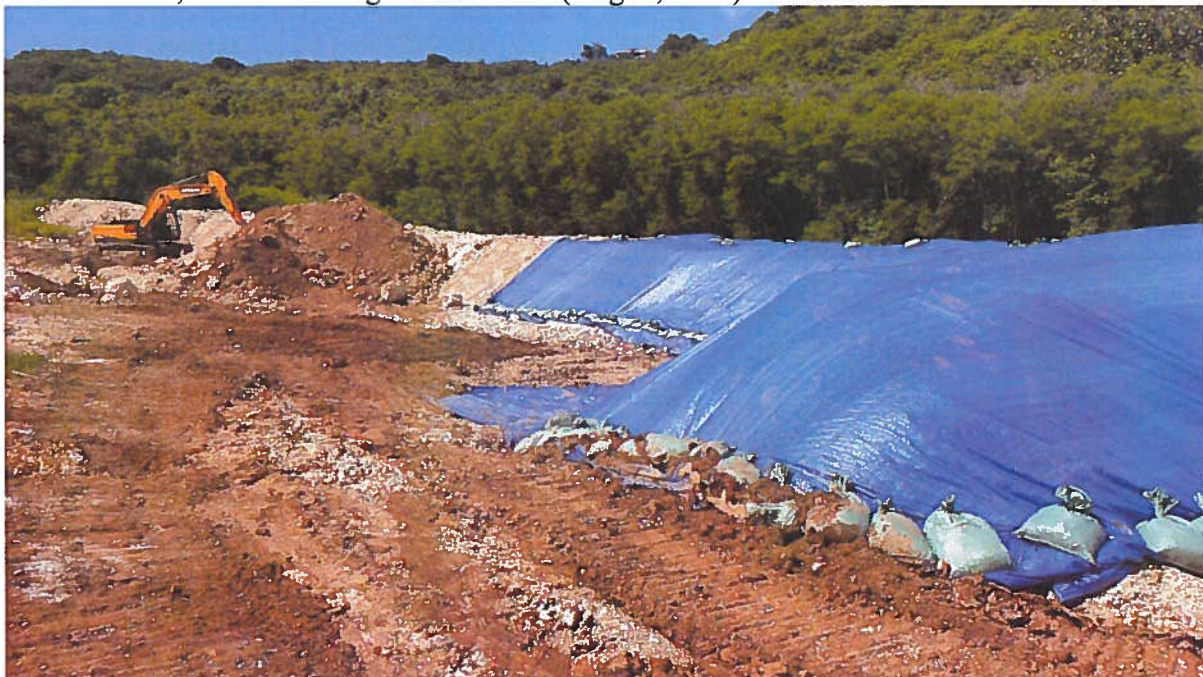
Closer view of temporary berm in Pond 5A and tarp to protect against wash-out caused by flow around its end, which discharges to Pond 5B (Aug. 4, 2021)

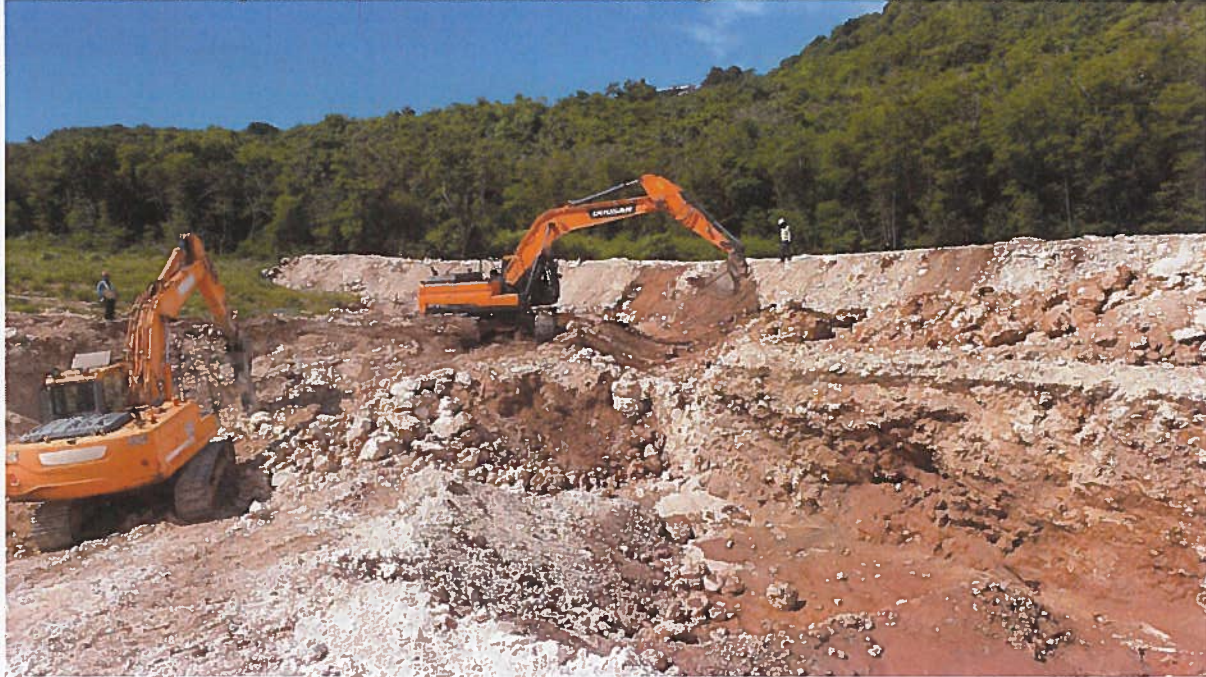
Work underway at Pond 5B to widen incoming swale and complete surrounding grading. The temporary berm can be seen behind the excavator with the worker standing on top. The blue tarp reinforcement was placed on the same berm but to the right, outside the picture. (Aug. 4, 2021)

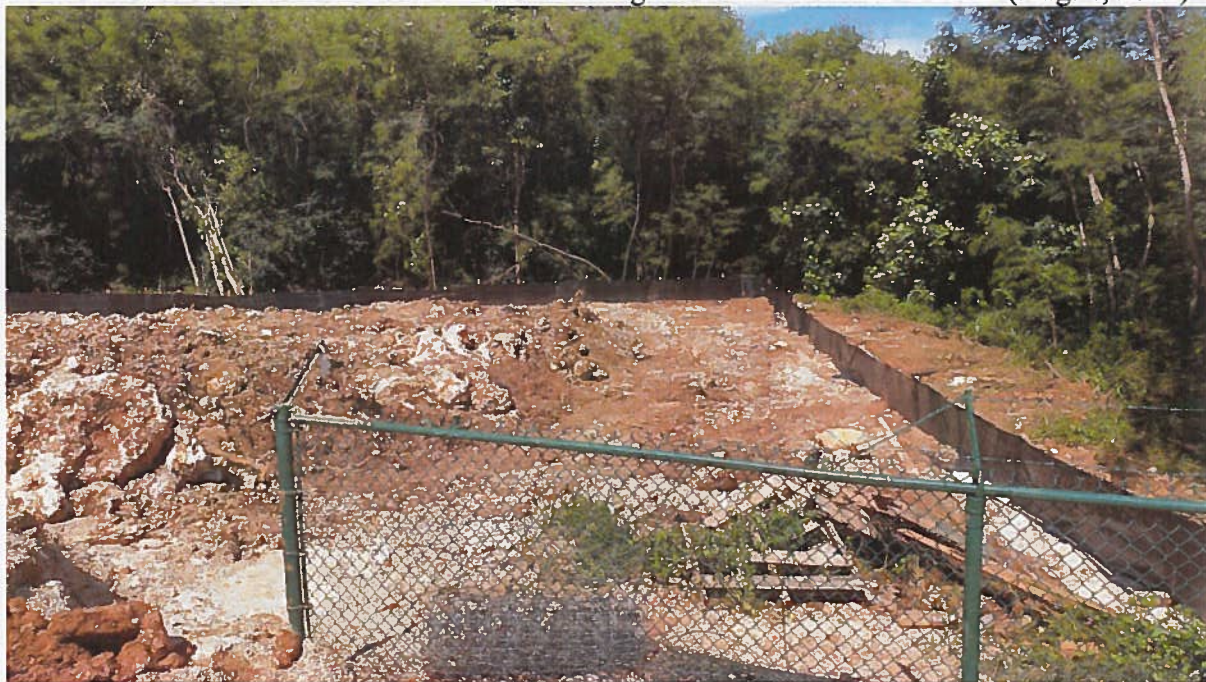
We then examined the area on the other side of the interim berm. In most places this was a relatively narrow area approximately 20-40 feet from the berm to the project fence, and protected by a single line of wire-mesh reinforced silt fence. However, in the area immediately behind the Pond 5 construction, the berm curves away from a sharp corner in the project boundary, leaving a roughly triangular-shaped area over 100 feet across at its widest point. Inside this area there was a pile of soil and debris, possibly remaining from the clean-up of the sediment discharge observed July 23. I observed that this poses a risk of further discharge of sediment from the site, and recommended that it be removed as soon as possible so that the soils in this area could be stabilized and revegetated. Samsung stated that they had been told not to excavate in this area by their site archeologist, and called our attention to flagging which marked areas where archeological work was still required to be performed.

Overview of the area below Pond 5, outside the temporary berm and located just up-gradient from Marbo Cave. This area is protected by a single line of silt fence. The remaining soil stockpile inside this area cannot be removed due to archeological work that needs to occur (Aug. 4, 2021)

3. The area between the Pond 5 system and the site boundary must be stabilized as soon as possible through revegetation or other means to prevent the stockpiled soils and bare surfaces in this area from washing off-site toward Marbo Cave. GEPA acknowledges that Respondent has been told not to disturb this area until archeological work is completed. Therefore, until the archeological work is completed and Respondent can begin soil stabilization work, extra attention must be paid to the maintenance of the silt fence at this location.

- Swales should be protected through the installation of stone check dams in accordance with the approved site plans.
- There was nothing Samsung could do about removing the stockpiled soil in the corner area above Marbo Cave until they are cleared by the archeologist to continue work in that area. Once they are cleared, the stockpiled material should be removed and the soil surface needs to be properly stabilized.

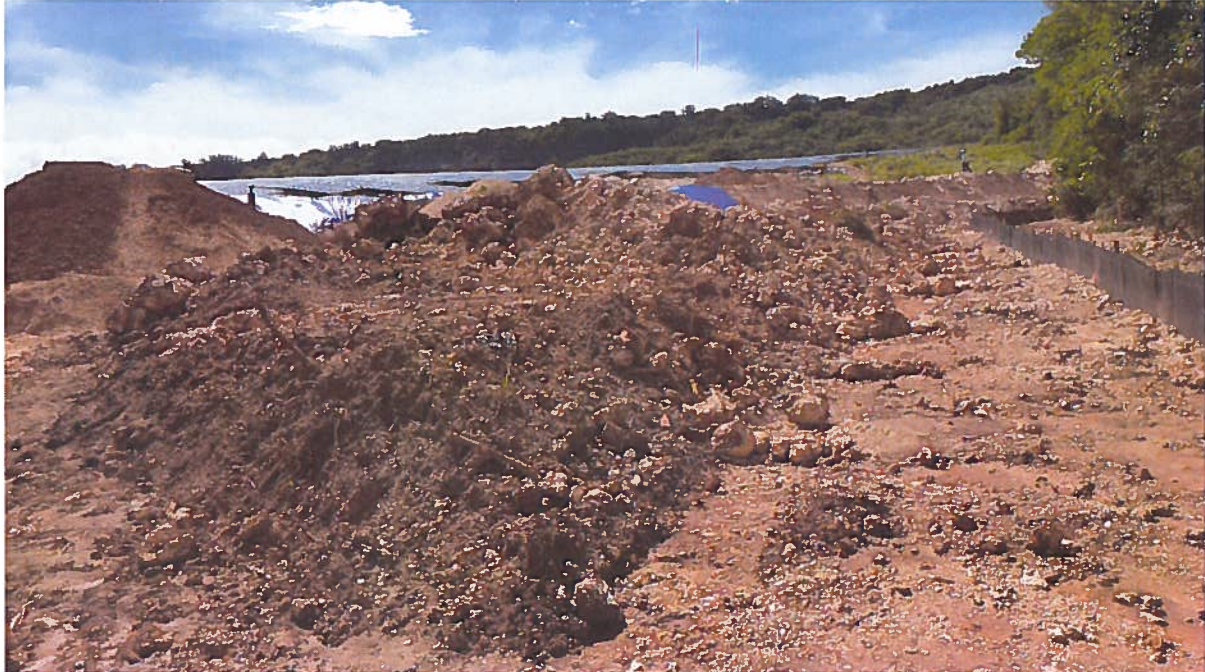
View of area outside temporary berm near Pond 5, showing flagging (orange) marking locations for archeological investigation, and stockpile of soil that still needs to be removed. (Aug. 4, 2021)

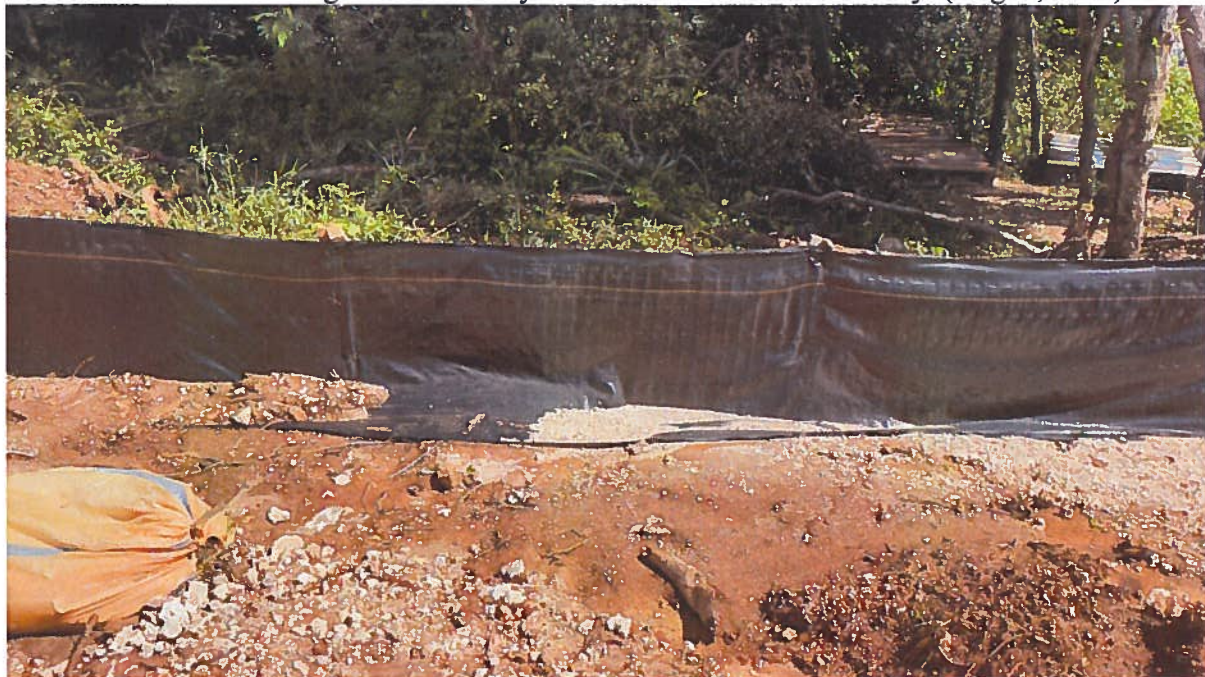
Within this area we also noticed that some of the silt fence had not been properly buried below the soil surface, and had instead been laid on top of the ground surface and covered with soil. The soil had been washed away by the recent rain events and exposed the bottom of the silt fence, however it remained in place because of the wire mesh reinforcement. We told Samsung that this must be corrected, and that silt fence fabric needs to be buried in accordance with standard silt fence installation details and the approved site erosion and sediment control plan. Samsung agreed and stated that they would correct this immediately.

Section of silt fence showing inadequate burial of fabric, and erosion of soil that occurred on recent rain event. Silt fence fabric remained in place, however, likely due to the use of wire mesh backing as reinforcement. Samsung stated that they would correct this immediately. (Aug. 4, 2021)

- Continuous inspection and maintenance of the berms, silt fences, swales and other measures would be required.
- Silt fence fabric must be buried properly in accordance with industry standard installation instructions, and that the area in the corner above the Marbo Cave area was of particular concern and the silt fence there needed to be properly installed right away.

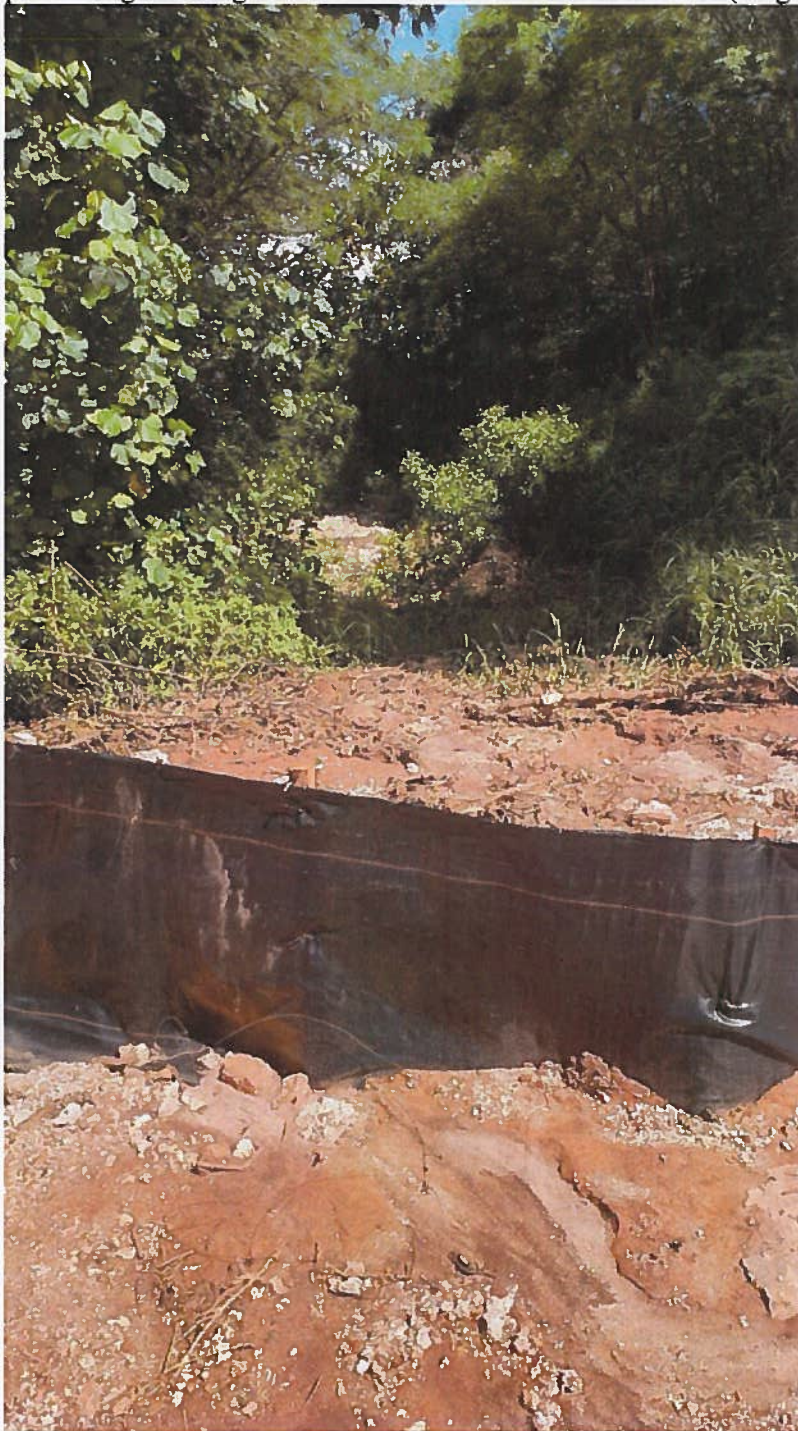
View looking past the silt fence just outside of Pod 5 area, down the trail toward Marbo Cave. Erosion from rainfall events of the previous day can be seen in the form of soil scoured from the improperly buried bottom section of the fence fabric. It appears that the silt fence was effective at preventing discharge toward Marbo Cave at this location. (Aug. 4, 2021)

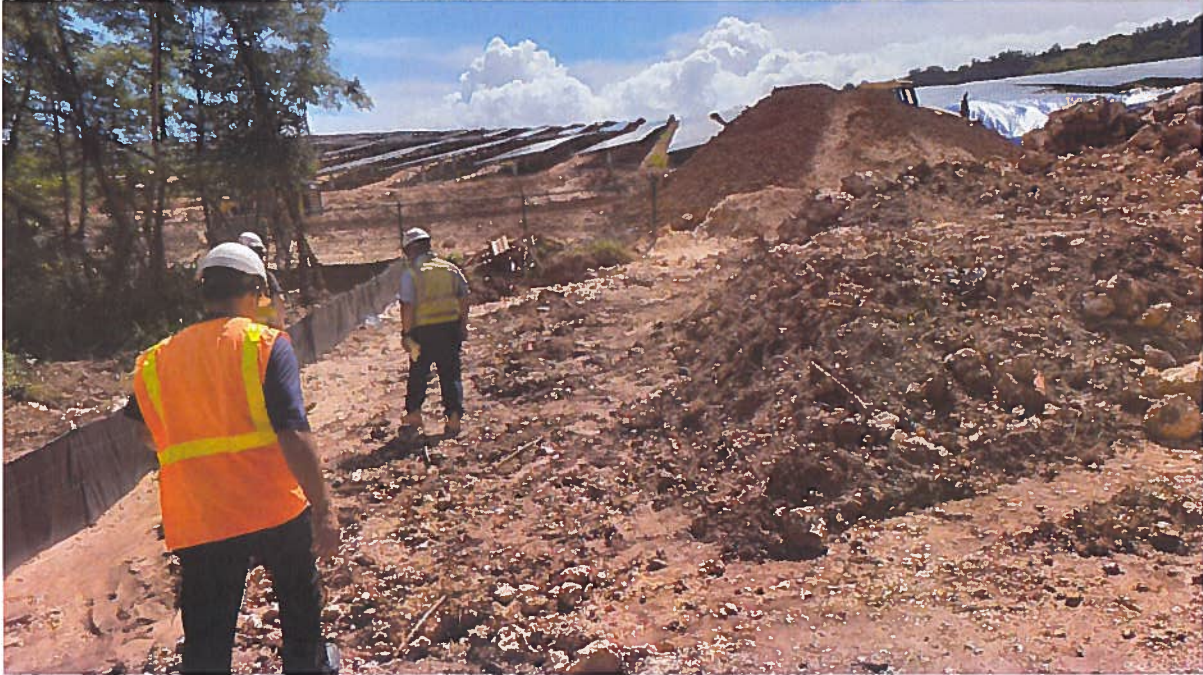
View from silt fence-protected area outside the temporary berm around the Pond 5 area, looking back toward active construction (compaction) of Pond 5B. The temporary/interim berm can be seen partly covered by the blue tarp on the right, and behind the compaction equipment on the left. (Aug. 4, 2021)

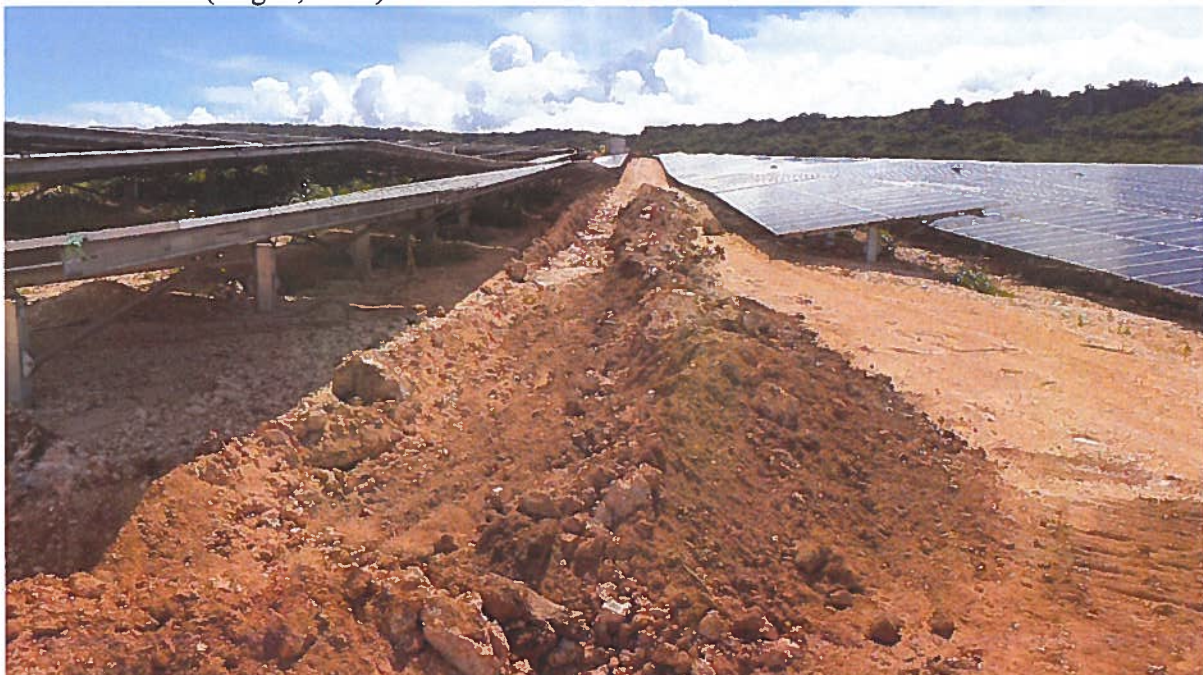
We began our inspection near the project office, located near Pond 4. We were shown a newly dug interior swale which began within the solar panel area above the area between Ponds 4 and 5. Samsung explained to us that the purpose of this swale was to divert surface runoff away from Pond 5 and into Pond 4, to reduce the pressure on Pond 5. They explained that one of the recent rainfall events had caused some erosion of the temporary berm between Pond 5A and Pond 5B, but the discharge did not leave the site and was captured in Pond 5B. The affected portion of the Pond 5A temporary berm had been reinforced with plastic tarp and sandbags. According to Samsung, after the new diversion berm was installed, the Pond 5 system had collected much less runoff and was no longer in danger of overfilling and washing out the temporary berm.

Start of new swale, which intercepts surface runoff within the site and diverts it away from Pond 5 and to Pond 4 (Aug. 4, 2021)

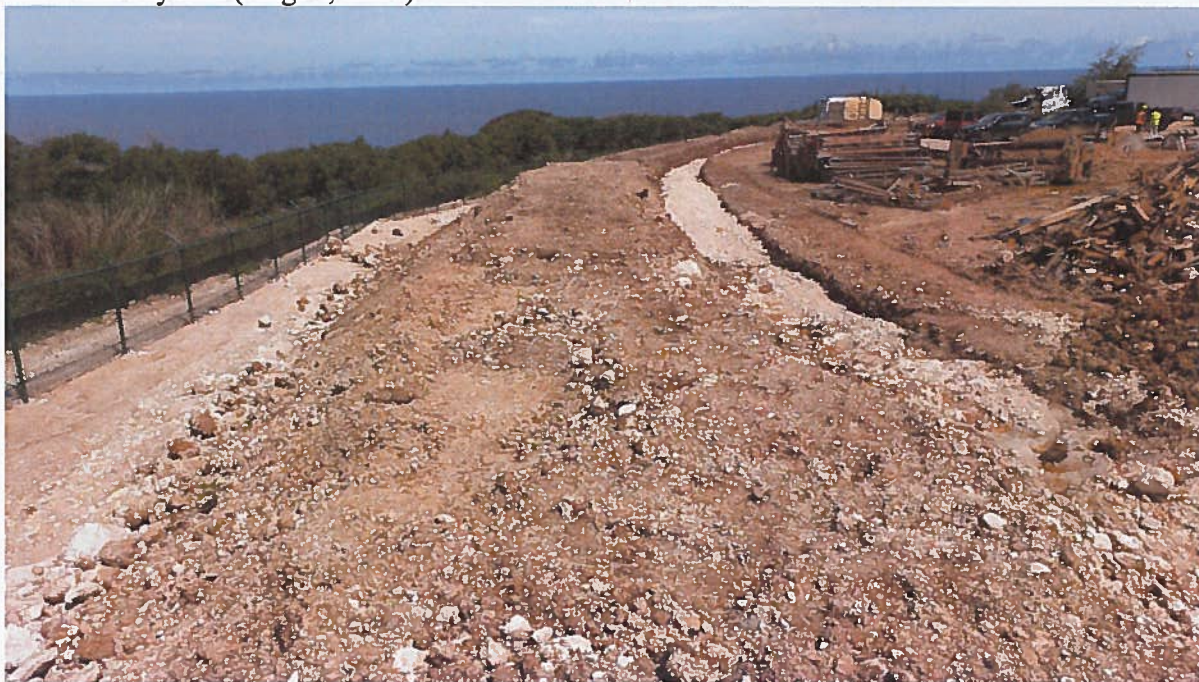
We then walked toward the Pond 4 area, and followed the new interior drainage swale. Along the way I pointed out erosion within the swale and sedimentation near its lower end, and told Samsung that their approved site plans included details and instructions for stone check dams, which were meant to be installed within site swales to slow water velocities and prevent erosion, until the site could be fully stabilized. They agreed to install the measures according to the plans.

Continuation of new swale, looking in direction of flow toward Pond 4. Also note line of silt fence located just past perimeter fence on left, which captures runoff and erosion from the top of the berm and beyond. (Aug. 4, 2021)

4. Interior site swales should be protected by the installation of stone check dams. See the officially adopted manual and field guide referenced above. The purpose of check dams is to reduce erosive flows and allow sediment to settle out, which reduces the amount of sediment reaching the sedimentation basins and conserves the capacity of those ponds to retain runoff from future storm events.

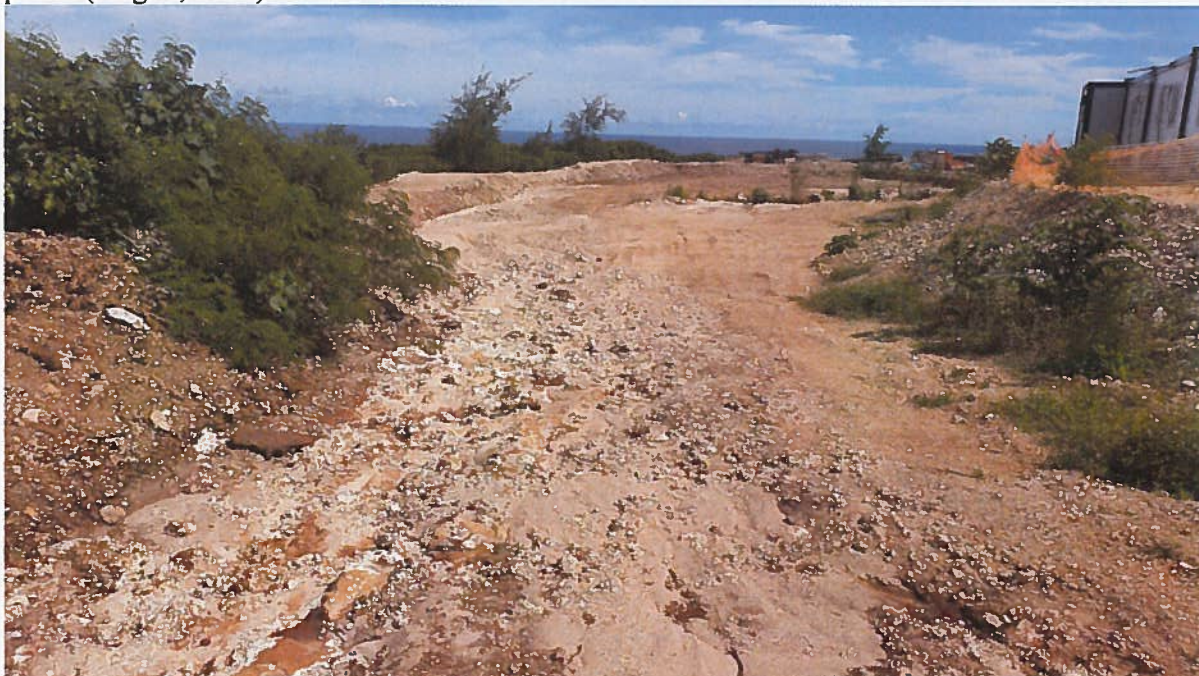
Discharge location of new swale into Pond 4. Berm seen here is a temporary berm put in place by Samsung to hold water in location of Pond 4, while permanent embankment construction takes place. (Aug. 4, 2021)

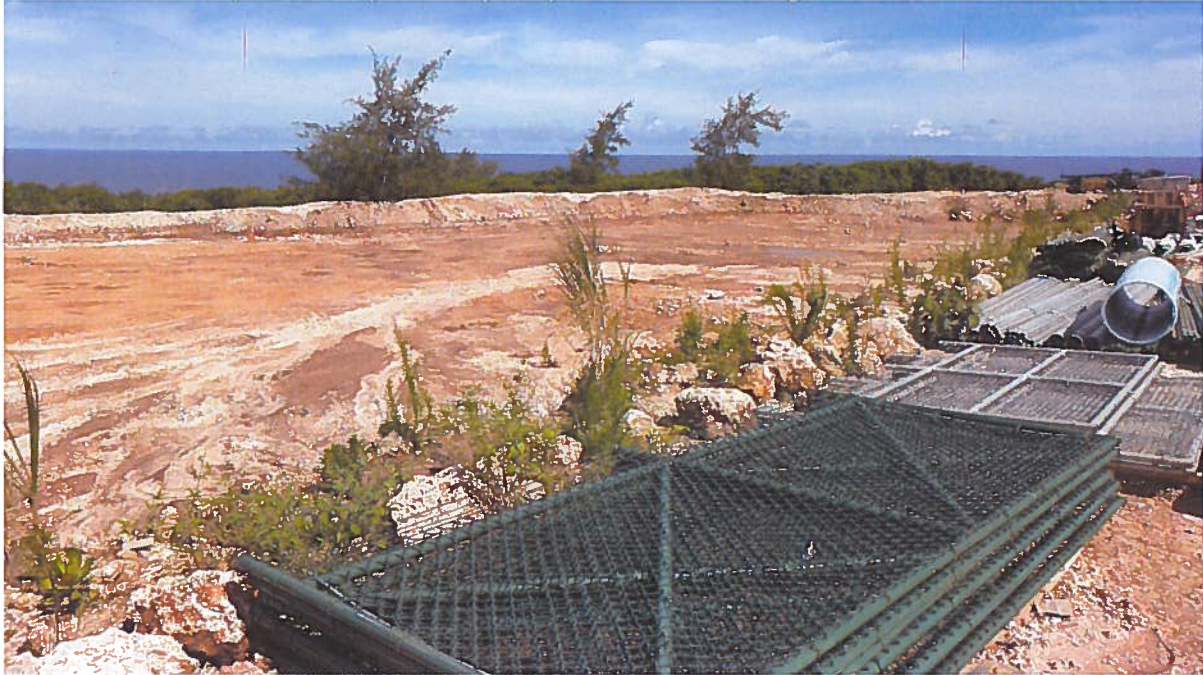
We were shown Pond 4, which is presently formed by the emplacement of a temporary (interim) berm, and is divided in half by another berm that has been placed to allow installation of the permanent Pond 4 berm to take place on the other half. Evidence of a high water mark was observable at the lower end of the active portion of Pond 4, indicating that the water level had

Pond 4, as currently formed by the temporary berm shown. (Aug. 4, 2021)

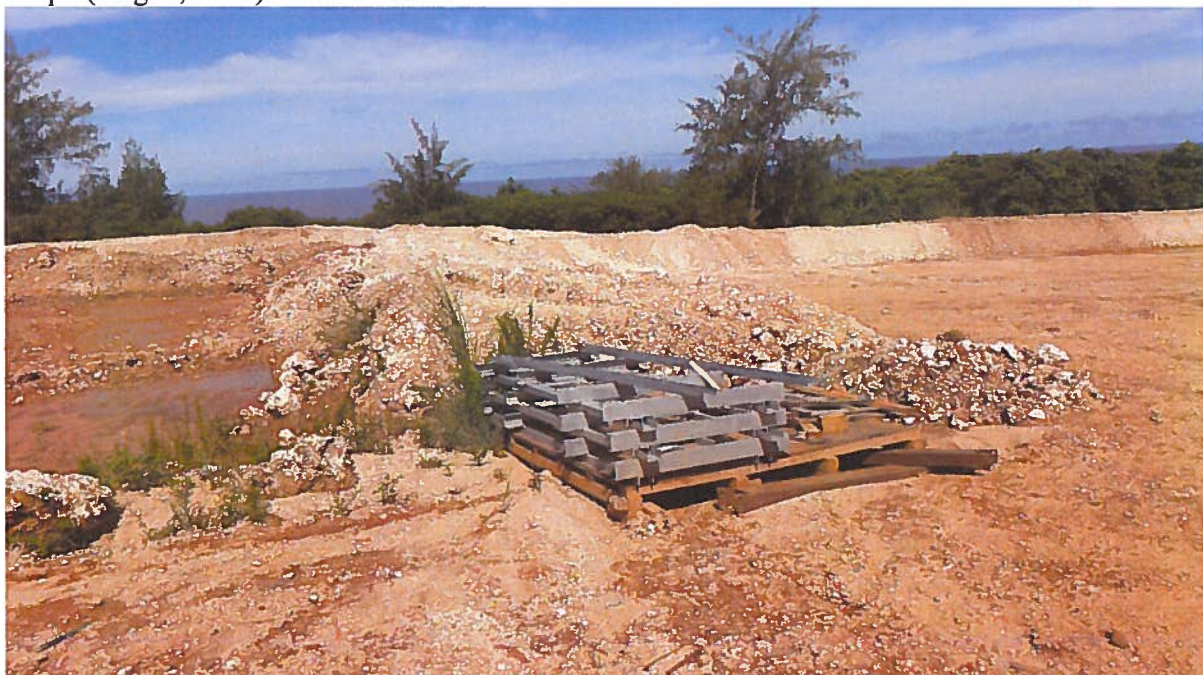
reached less than about 1 foot above the bottom of the berm during the recent rain events. The berm appears to be about 4 feet high.

Temporary berm placed about halfway into Pond 4, designed to keep water out of the other half (to the right) while construction of the permanent pond embankment takes place. The high water mark from the previous days' rainfall events can be seen on the face of the berm, less than 1 foot deep. (Aug. 4, 2021)

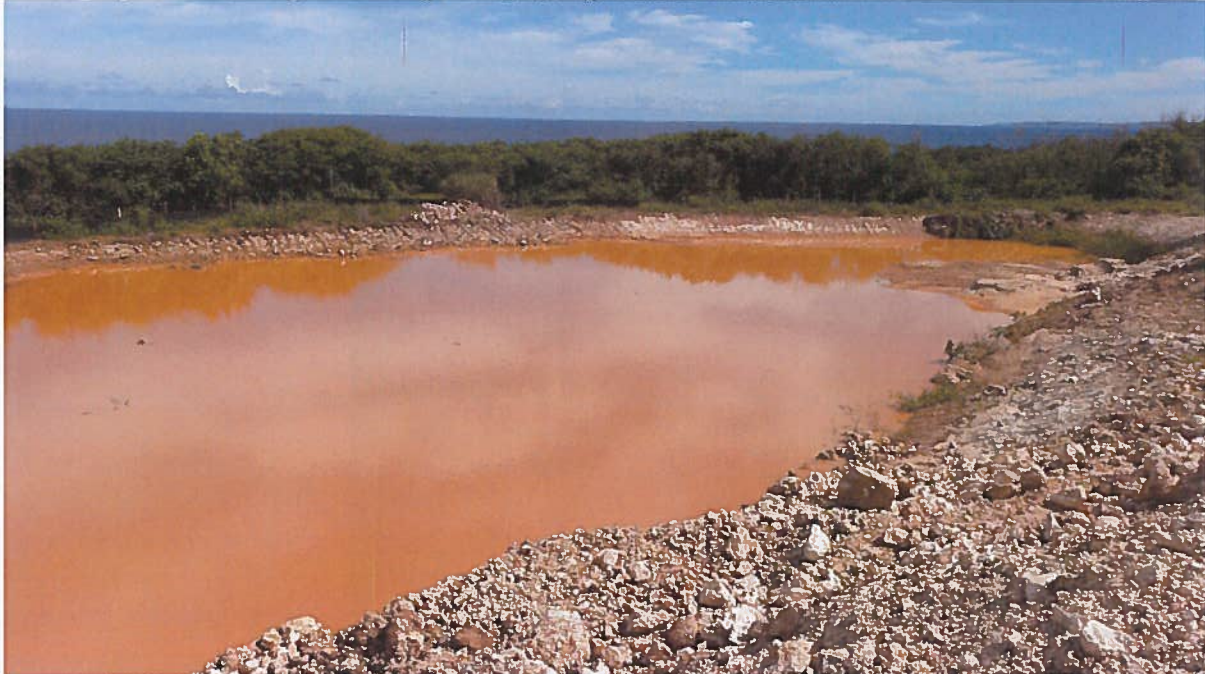
We also examined Pond 2, which still held a considerable amount of water and sediment. We were shown a new swale which had been installed along the southern boundary of the site to better capture runoff and discharge it to the pond. While we were in this area, someone drove past us toward the site office and waved at the Samsung staff. I asked who that was, and the Samsung staff informed me that was the Fichtner representative. Fichtner is identified on the site project sign as the "consultant" representing the owner, Kepco.

Pond 2, showing sediment load which was captured from new swale added along the south border of the project site (to right side of picture). (Aug. 4, 2021)

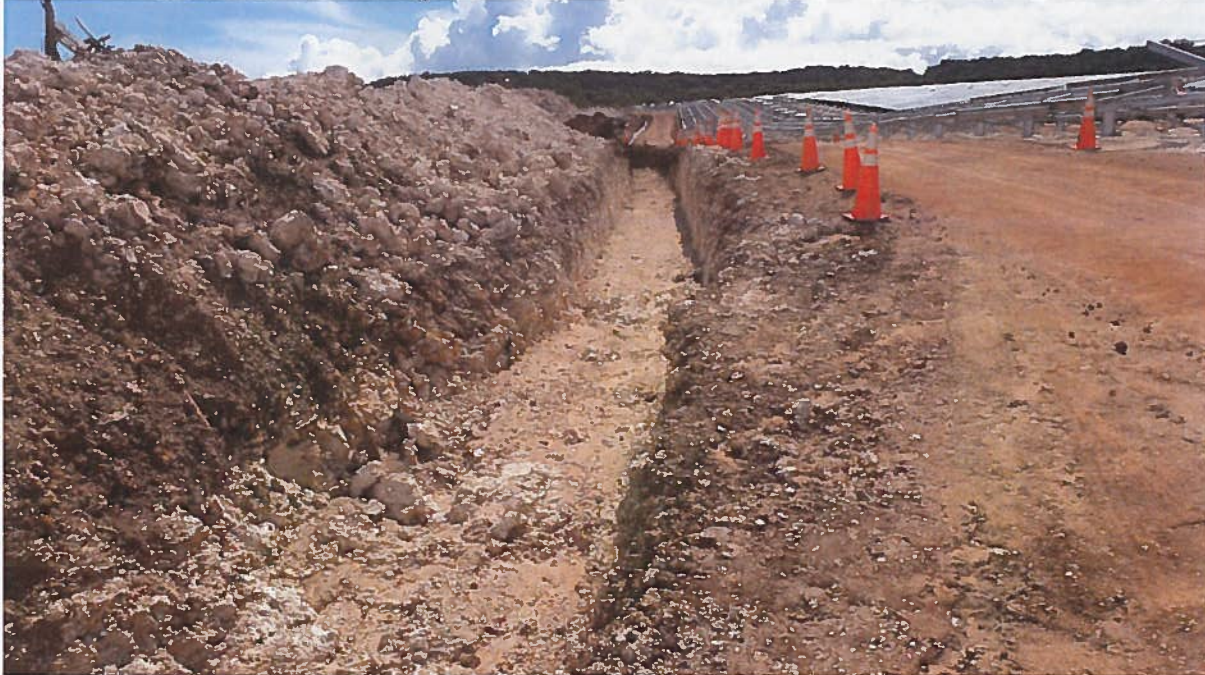
View of new swale installed to capture runoff from south boundary of project. (Aug. 4, 2021)

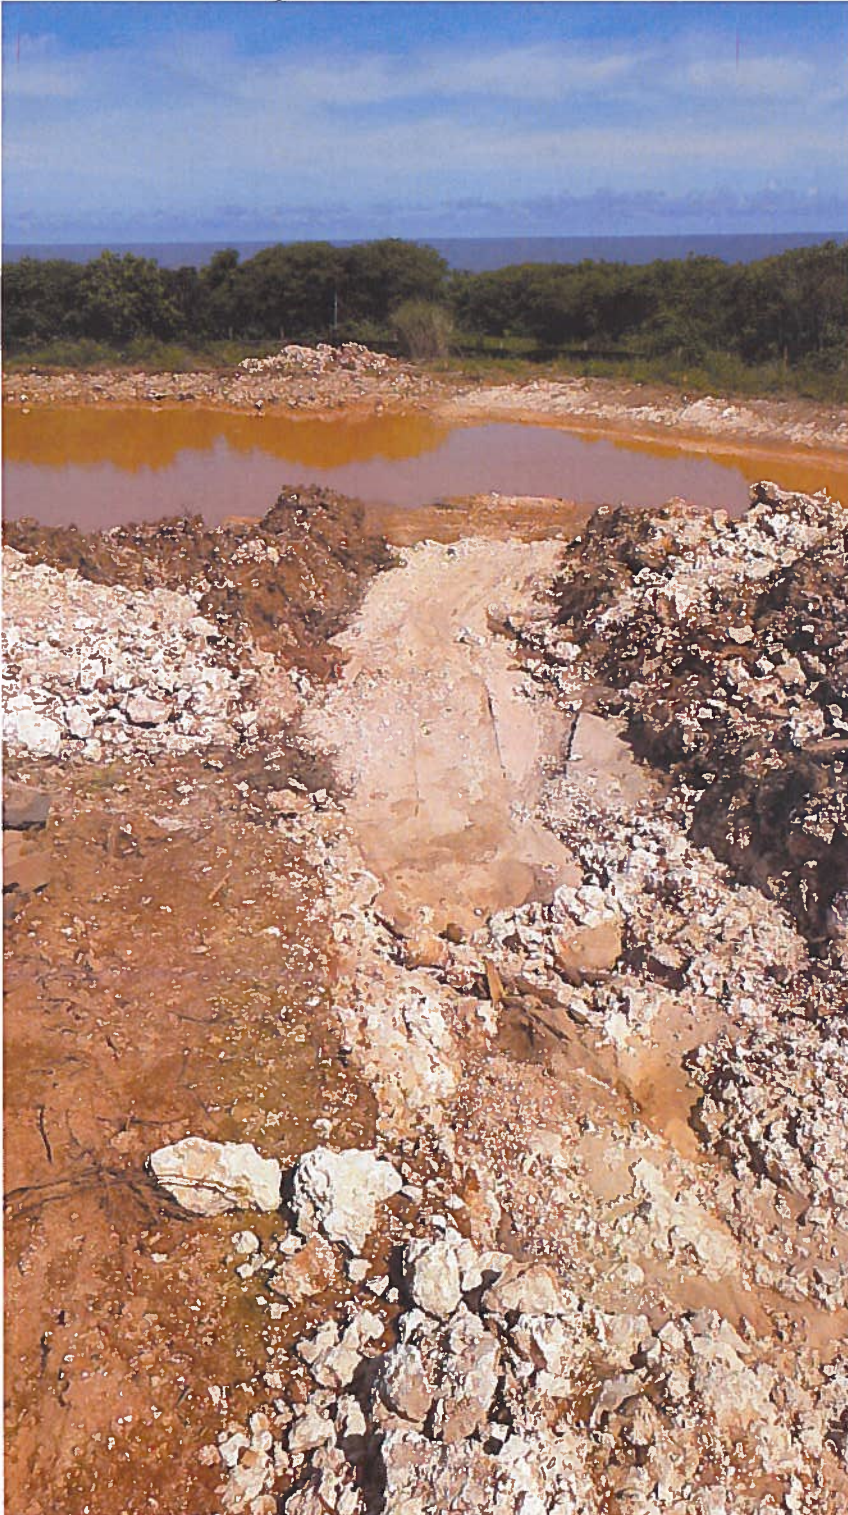
Sediment load from new swale resulting from rain events over the previous few days, captured by Pond 2 as shown. (Aug. 4, 2021)
